PARADISE DAM

FLOOD EVENT OF JANUARY TO MARCH 2013

REVIEW OF DAM SAFETY MANAGEMENT ACTIONS

REPORT NO. DC 13127

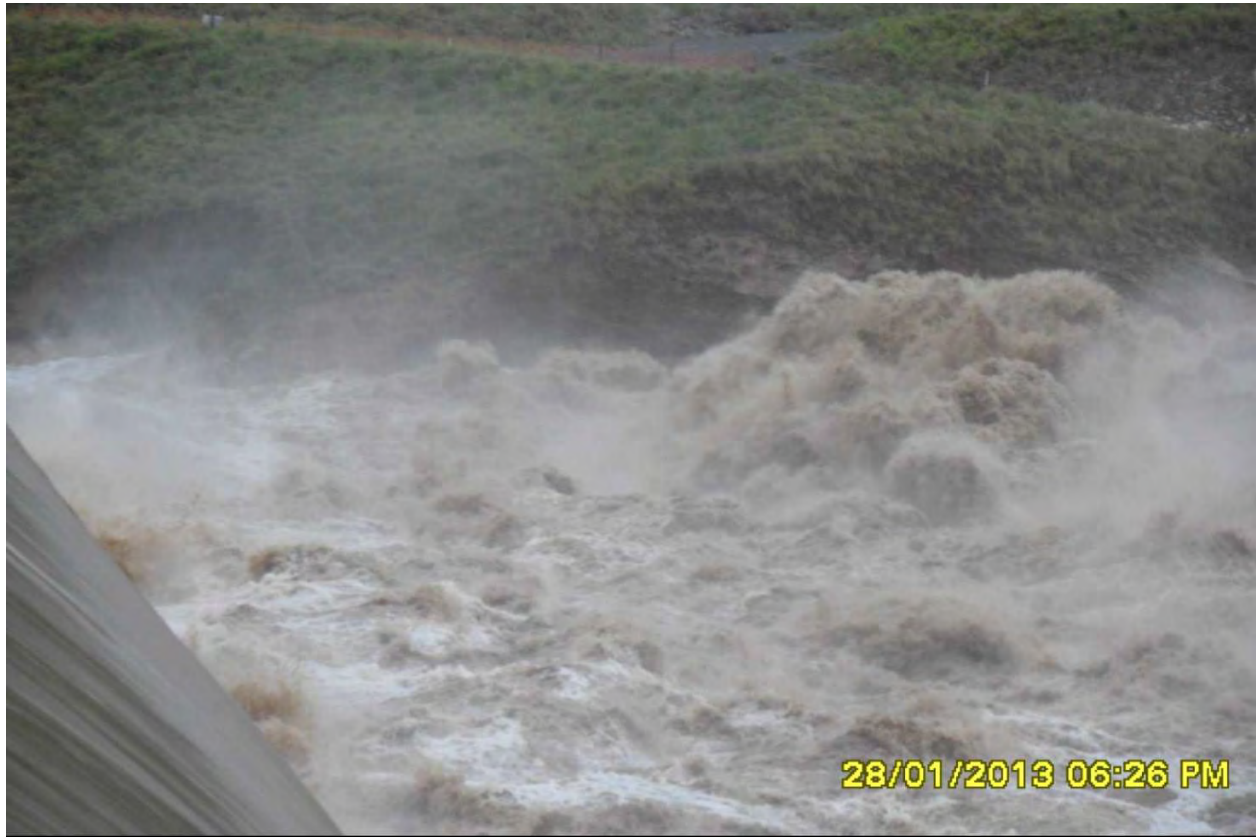
Figure 2, being document SWA.502.001.3202 provided for this review, shows the discharge under peak flow conditions at 1826h on 28 January 2013. The turbulence of the flow gives a graphic impression of the very large energy dissipation which is occurring.

Figure 2 – Turbulent Flow at the Left End of the Spillway

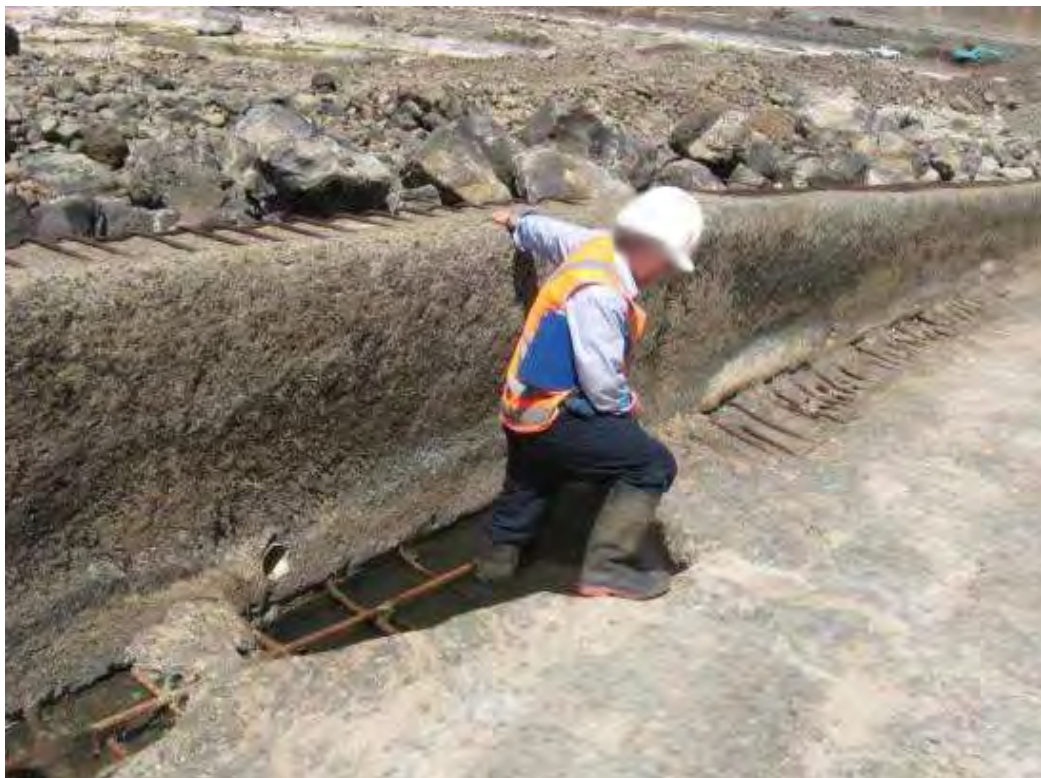
2. Rock and gravel are drawn into the dissipator – the end sill and the left training wall were rounded by abrasion to an extent that exposed the reinforcing steel. That damage was only of cosmetic significance in the short term but would cause problems of steel corrosion in the long term. There was some localised damage which was indicative of more serious abrasion as seen in **Figure 3** (taken from the 2010/2011 damage inspection and civil works rectification report, SunWater June 2013).

Figure 3 – Abrasion through Dissipator Apron

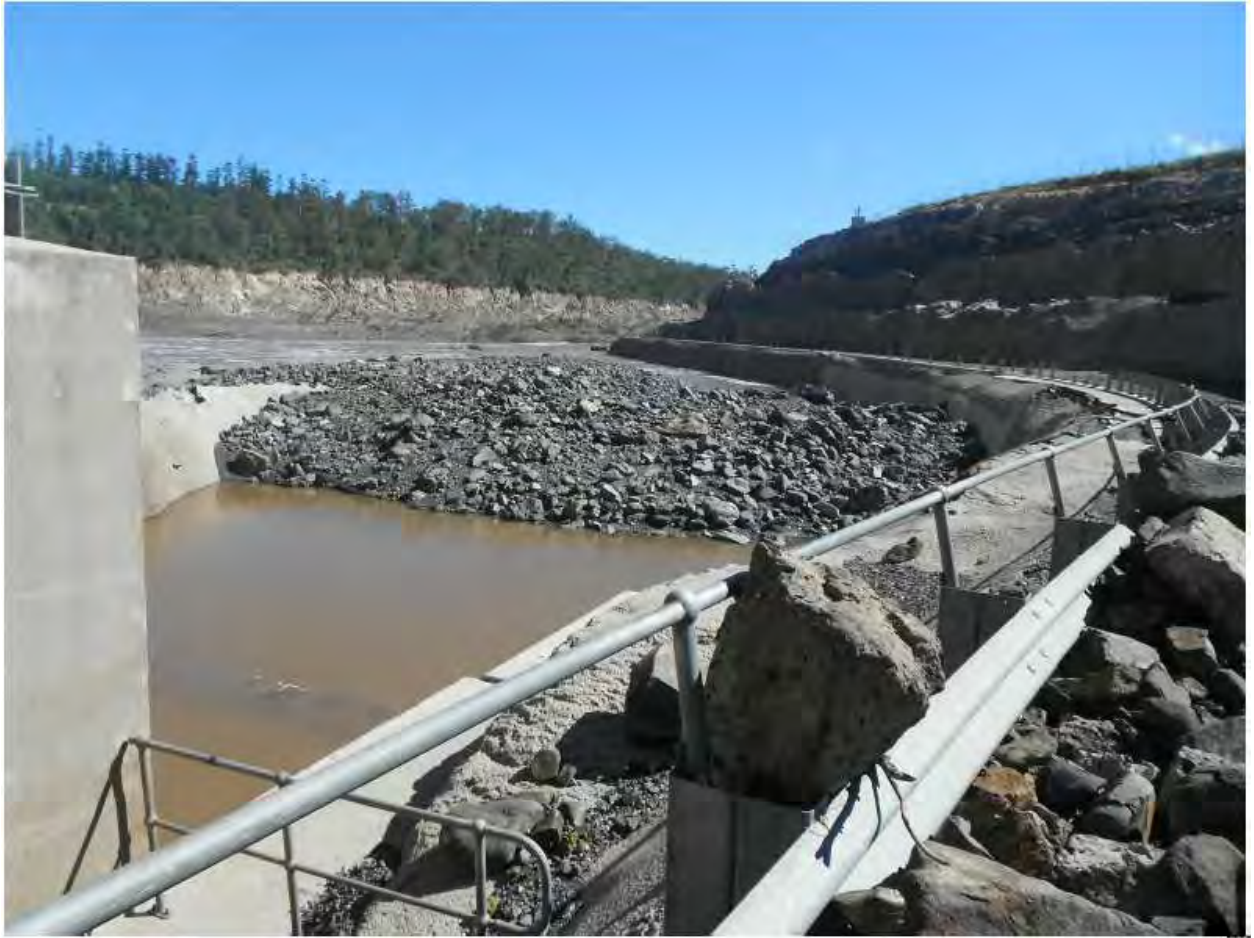
3. Observed behaviour of dissipation flows – a hydraulics specialist, [REDACTED], was engaged by SunWater to advise on the spillway performance during the 2010/2011 flood event. His report is [REDACTED] (2012). The first issue to be noted from his advice is that the spillway flow is not two dimensional as would normally be expected in a long uncontrolled spillway. This is mainly attributed to the rise in the elevation of the dissipator apron toward the left end of the spillway. [REDACTED] believes that the recirculation pattern which has been set up is accentuated by the scour which occurred on the lower left abutment in the 2010/2011 flood event and that this recirculation is a mechanism for feeding rock and gravel back into the dissipator apron. Eric recommended that measures be taken to interrupt the recirculation flow. No such measures have yet been implemented. This relates to the potential abrasion problem mentioned under our preceding point.

Figure 6 – Rock and Gravel in the Near Vicinity of the Dissipator

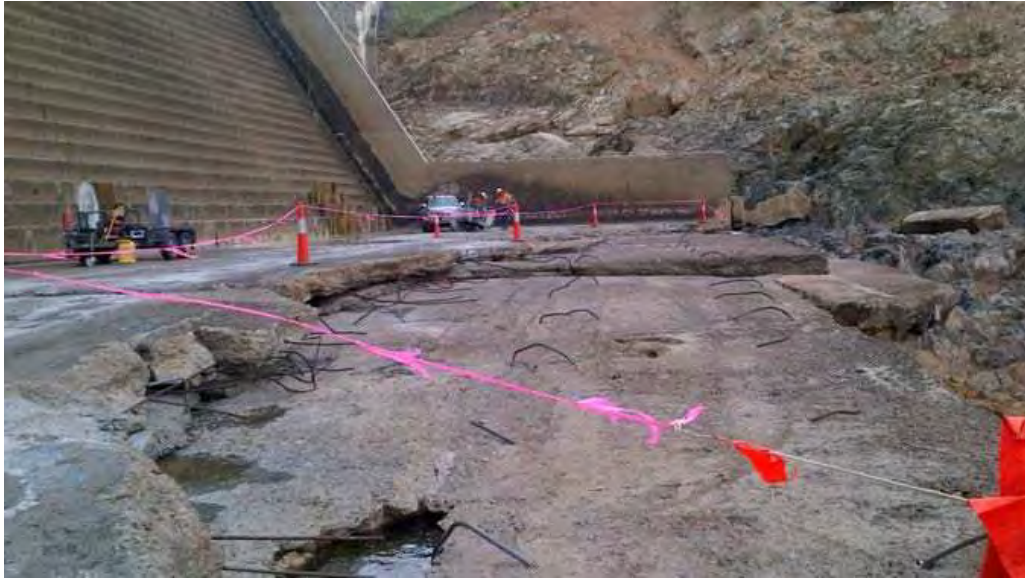
3. The dissipator apron can be seriously damaged, if not destroyed, by high energy flows – there was relatively minor damage to the RCC apron during the 2010/2011 flood event. According to [REDACTED] (2012) this damage was due to abrasion by rock and gravel rather than to cavitation. On the evidence observed by us that conclusion is correct. In the 2013 flood the damage to the apron was on a much greater scale but was not due to abrasion. This time the evidence points to separation of the RCC layers at the plane of the reinforcing steel and destruction of the RCC above that level by pounding from the high energy discharge jet. **Figure 8**, taken from the interim design report (SunWater 7 June 2013), is strong evidence for that mechanism, as is **Photo 11** of **Appendix C**.

Figure 8 – Damage to Dissipator Slab from 2013 Flood

A point of significance in **Figure 8** is that there is a hole in the RCC below the plane of the reinforcement. The question is whether a future flood could destroy the dissipator slab. The damaged section shown in **Figure 8** has been replaced by anchored conventional concrete from Ch. 209 to Ch. 260. Another damaged section has likewise been replaced between Ch. 302 and Ch. 335. The “Ch.” refers to chainage measured parallel to the dam axis. The replaced sections of apron would be substantially more robust than the original RCC apron. The available evidence shows that:

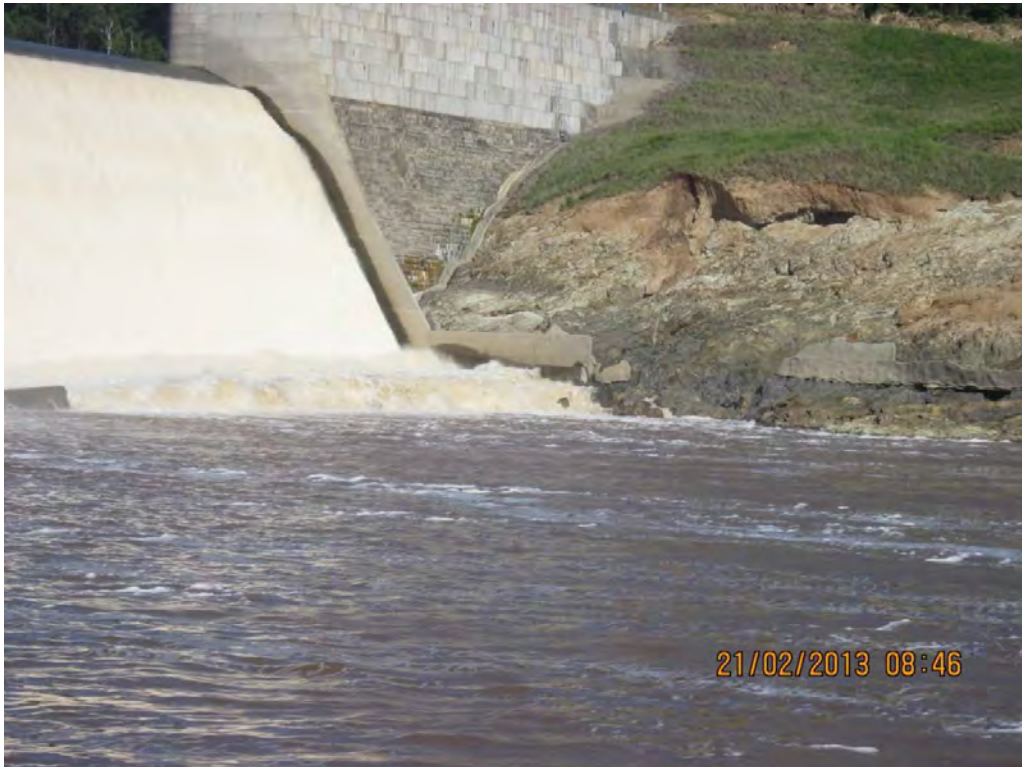
Figure 10 – End Sills Destroyed at Left End of Dissipator

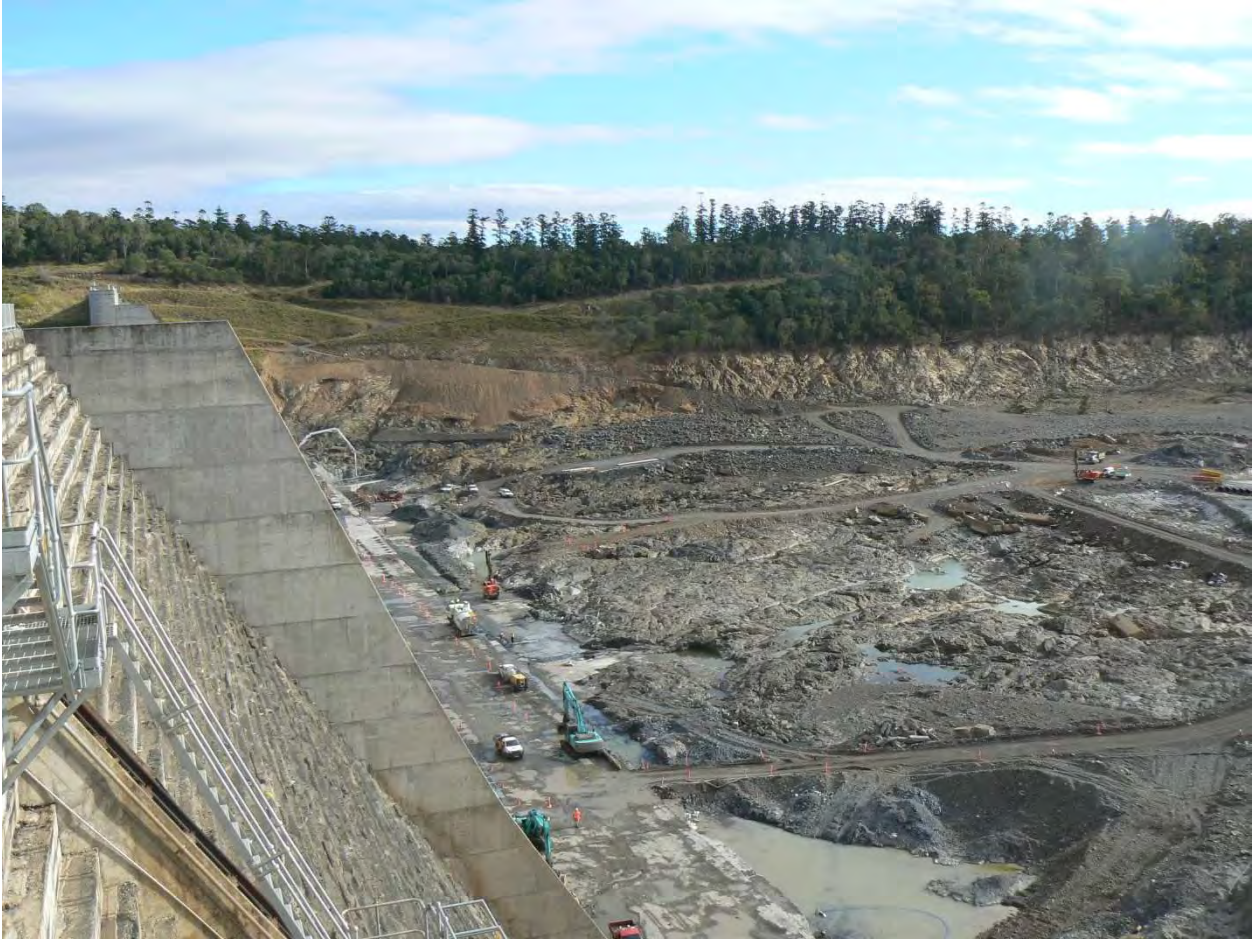
The inspection commenced on the crest at the right side of the spillway. There was a good overview here of the downstream side of the dam where concrete was being poured for the Phase 2 remedial work at the left end of the spillway. The extent of rock scour during the January to March 2013 flood event was evident. Damage to the valve house area could also be appreciated. **Photo 1** is an overview of the remedial works area.

Photo 1 – Remedial Work

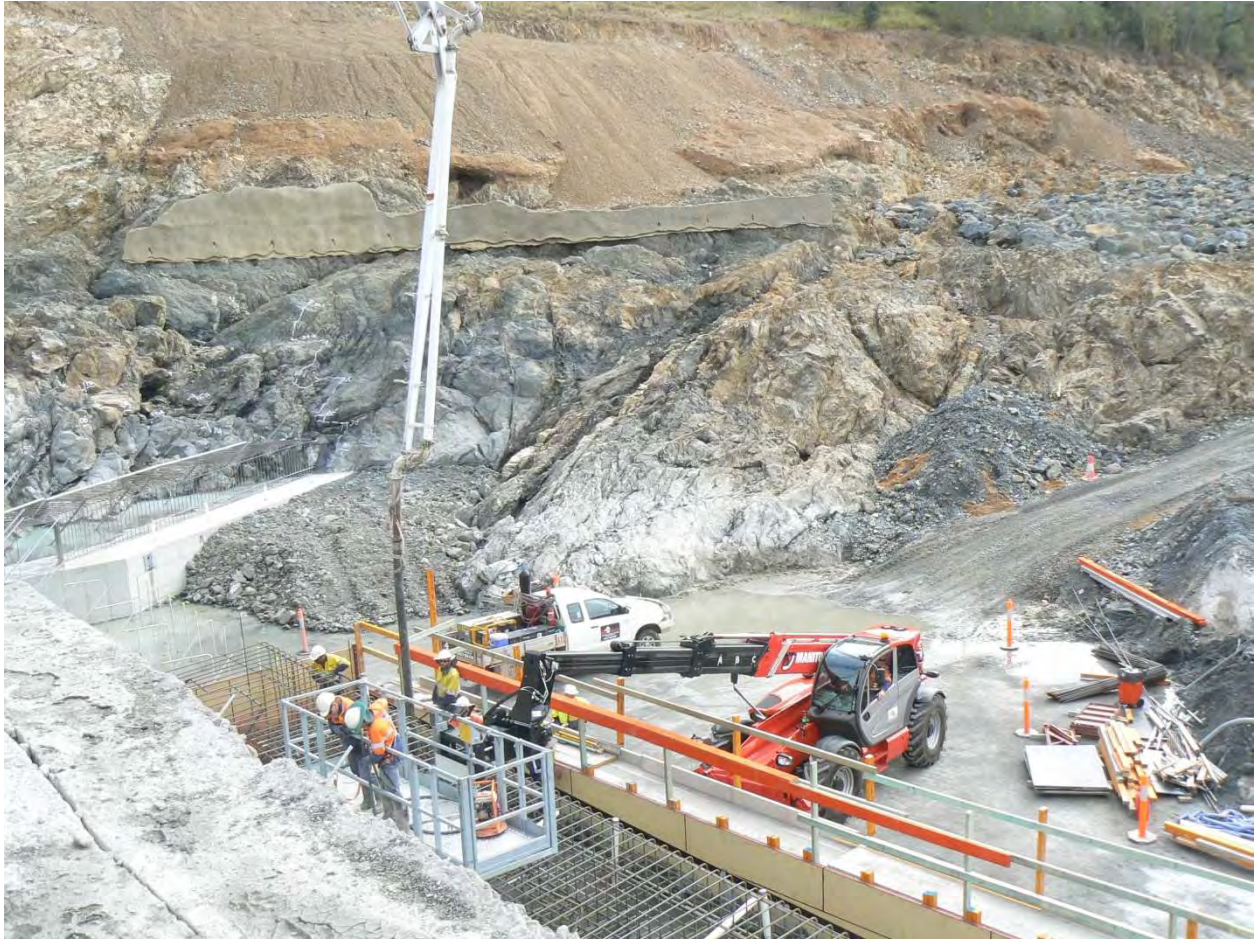
The left end of the spillway dissipator apron was then inspected. Concrete was being poured in the large scour hole immediately downstream of the apron. The damaged area of the apron had already been reinstated in conventional concrete. Geologic features were observed which it could reasonably be inferred had contributed to the deep scour in this area. **Photo 2** shows one such feature.

Photo 2 - Shear Feature (just right of concrete boom)

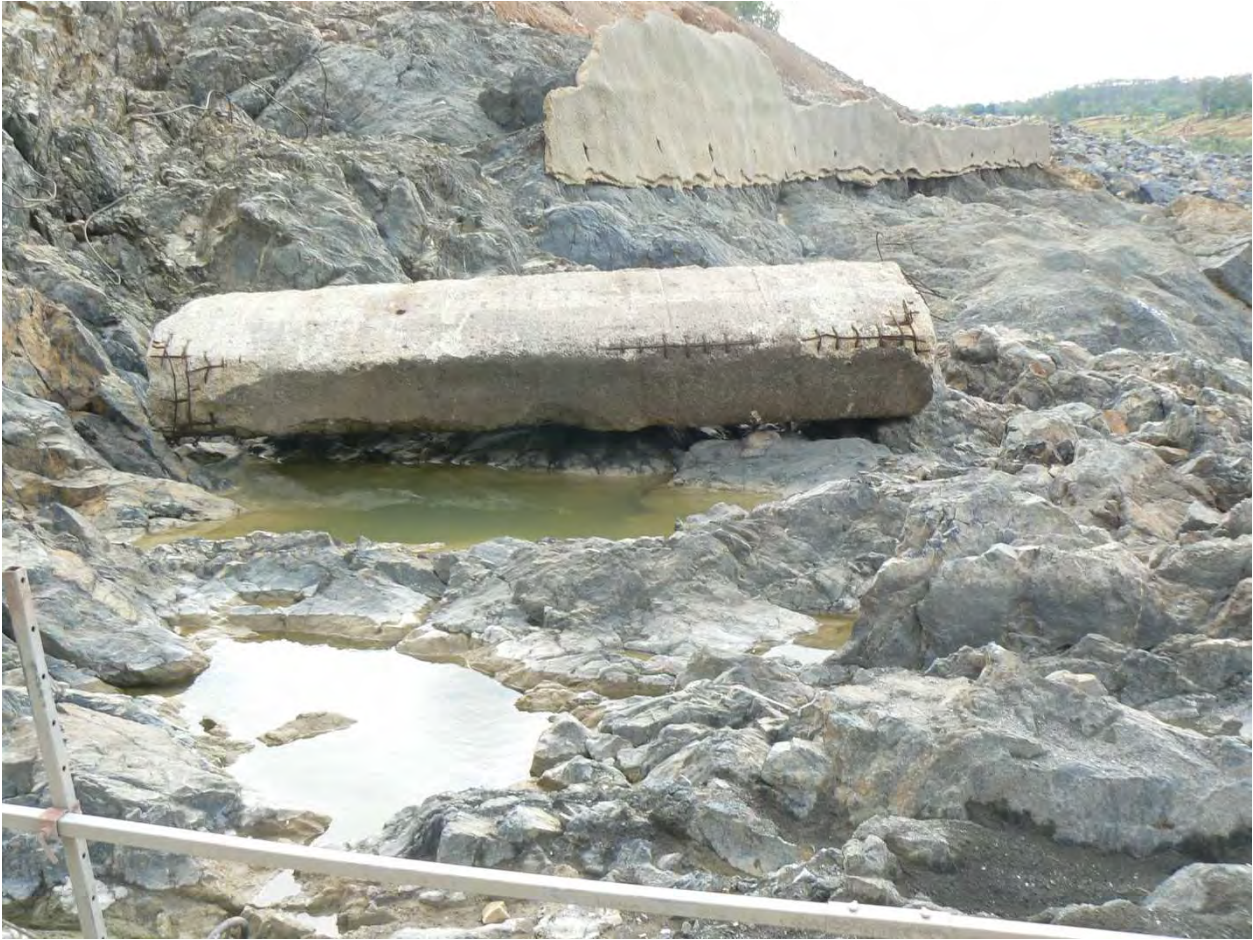
At the base of the left abutment slope a block of the dissipator end sill could be observed as in **Photo 3**. Many such blocks litter the downstream area, some hundreds of metres downstream. All of those observed had been abraded by rock and gravel drawn into the dissipator in the earlier 2010/2011 flood event. The abrasion had been sufficient to expose the reinforcing steel as is evident in the photo.

Photo 3 – Sill Block at Base of Left Abutment

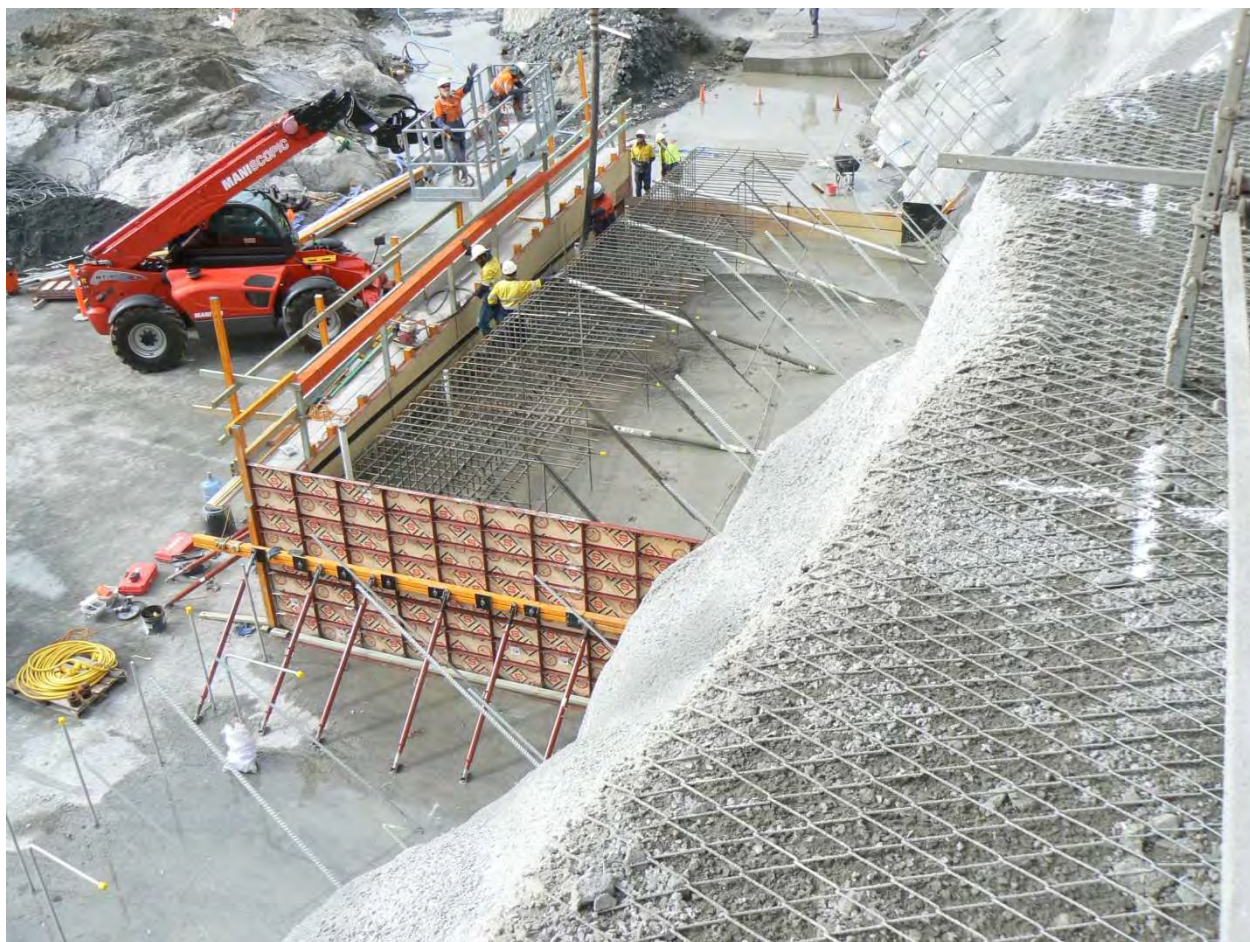
Photo 4 – Preparing for Concrete to Protect Steep Scour Face at Left End of Spillway

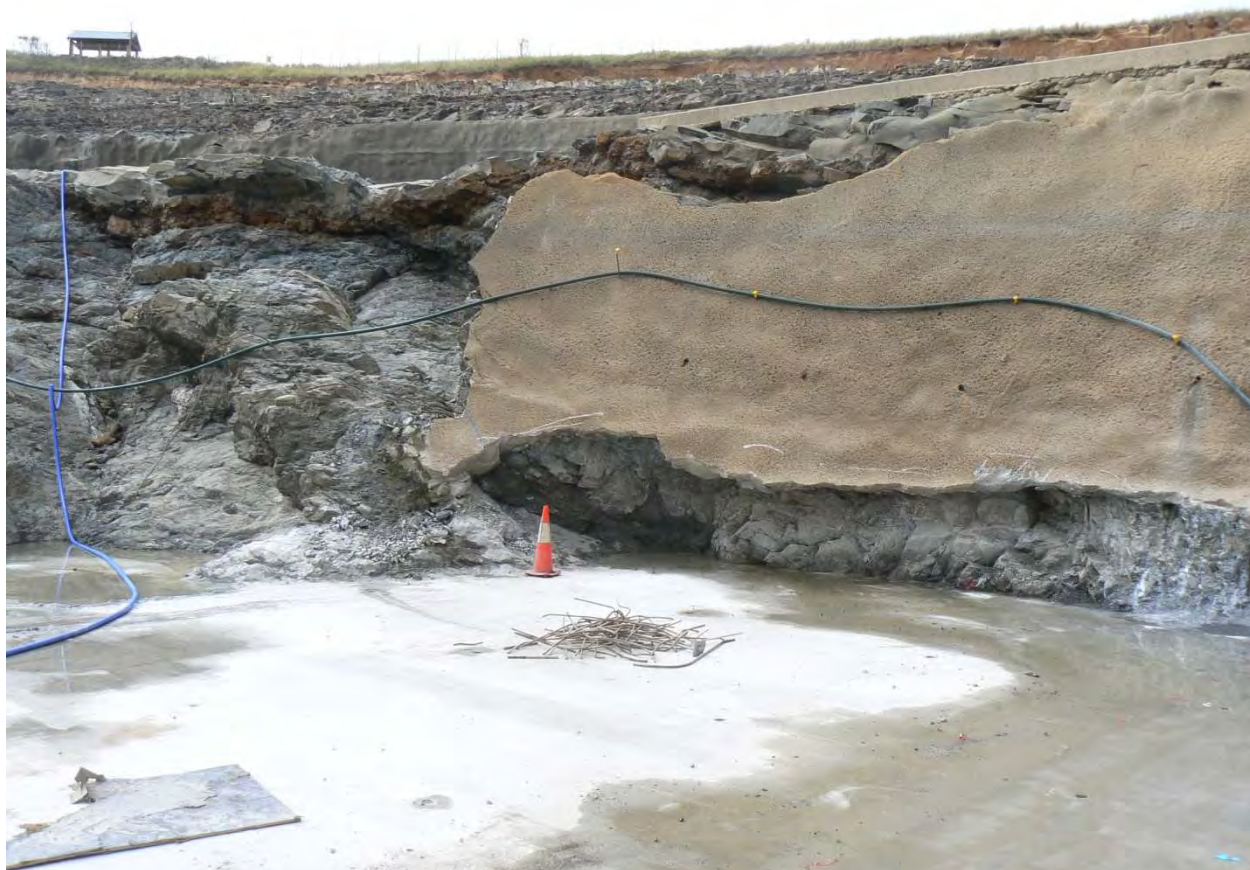
Photo 5 – Scour Hole at Right End of Apron Repaired

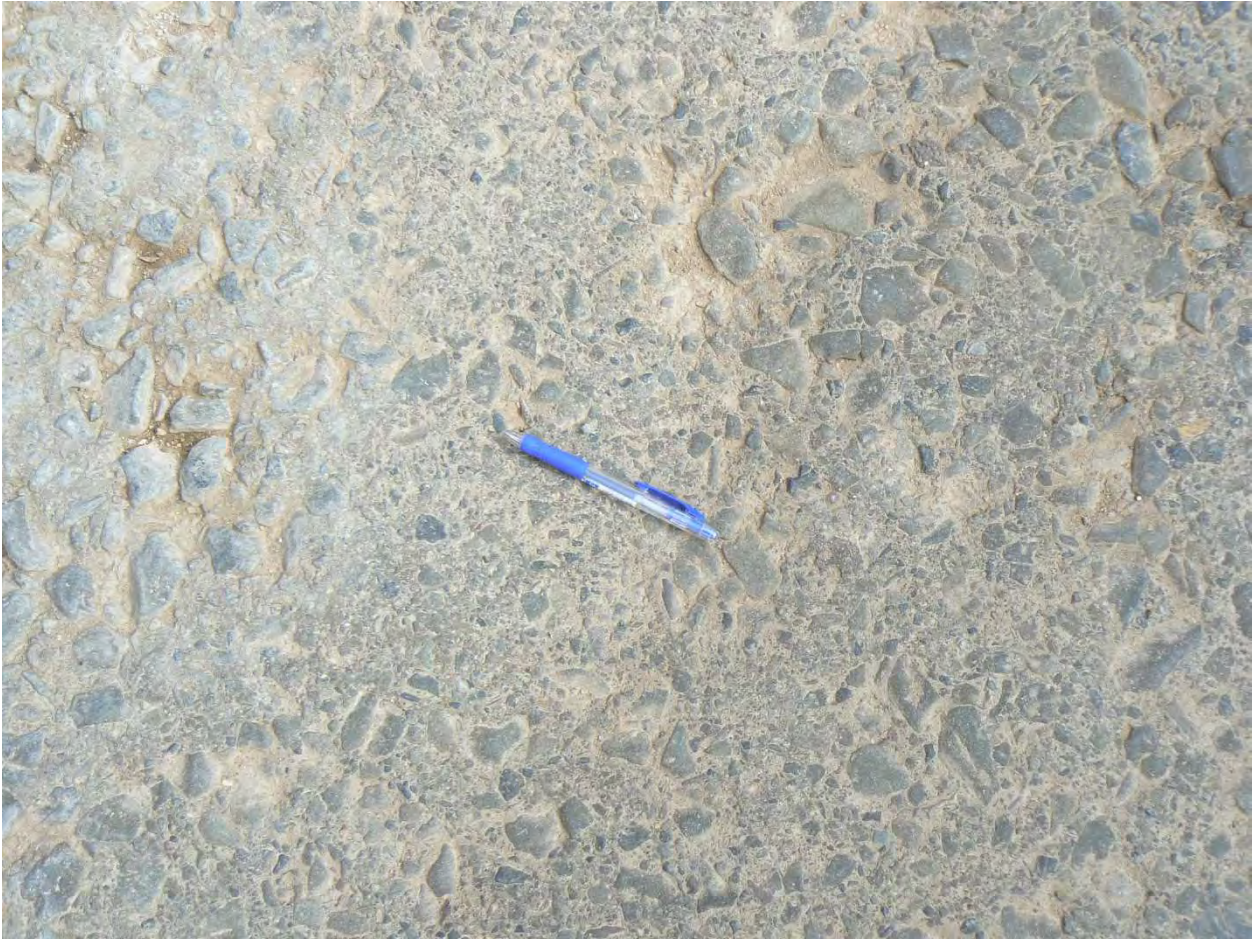
Examination of the remaining original RCC sections of the dissipator apron did not reveal any serious abrasion from the January to March 2013 flood. **Photo 6** shows the typical condition of the surface of the apron. This result is in contrast to the experience of the 2010/2011 flood when quite marked abrasion occurred on and adjacent to the end sill.

Photo 6 – Condition of RCC Surface of the Dissipator Apron

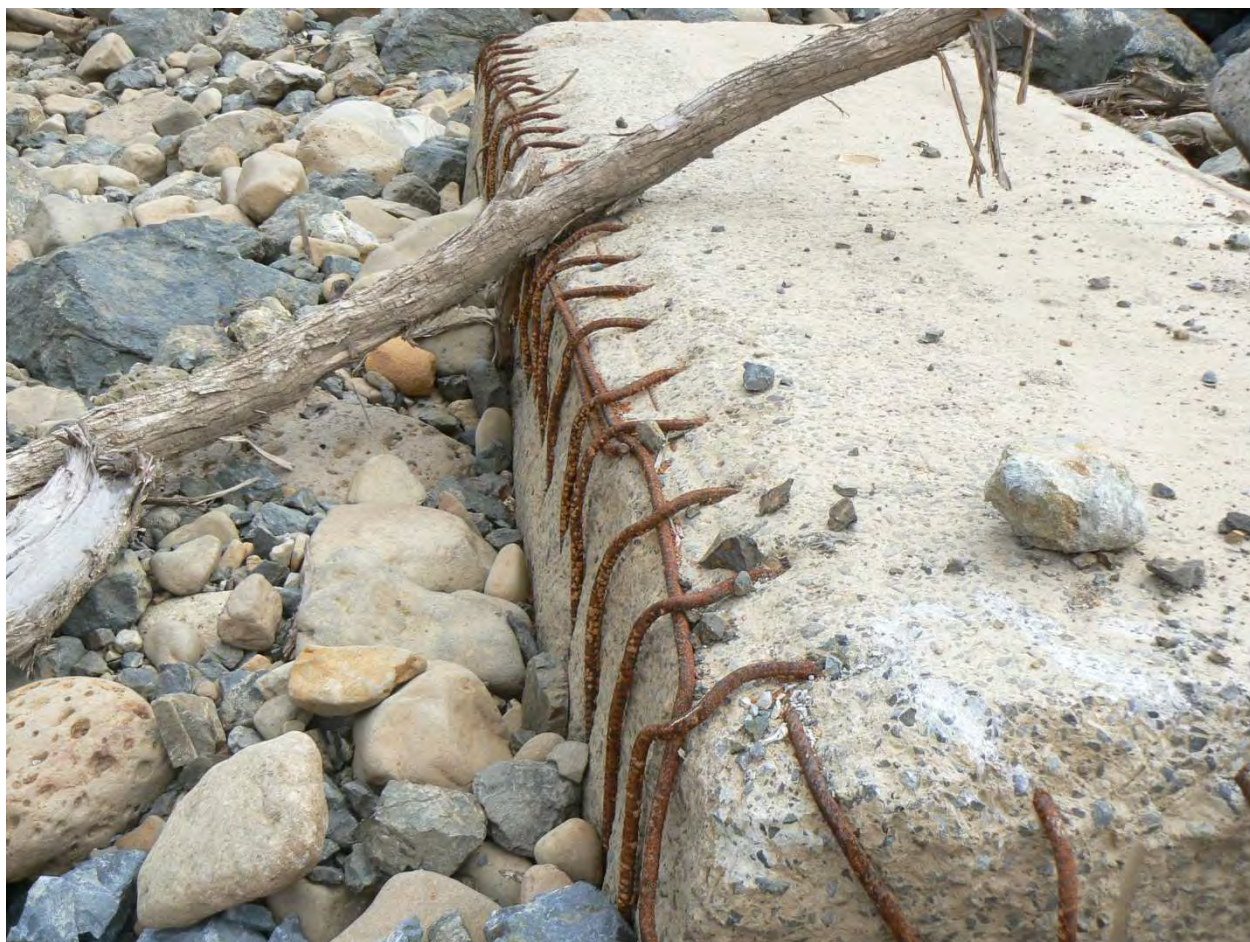
About 150m downstream of the apron an inspection was made of another end sill block. **Photo 7** shows this block. Though weighing some seven tonnes this block had been carried 150m from its original location. The abrasion by rock and gravel in the 2010/2011 flood is clearly seen. As observed with other blocks the reinforcing steel had failed in tension indicating that the high velocity water jet from the spillway had imposed loads in excess of the end sill's structural capacity. The classic "necking in" of reinforcement bars typical of a tensile failure is clearly evident in **Photo 8**.

Photo 7 – A 7 tonne sill block carried 150m

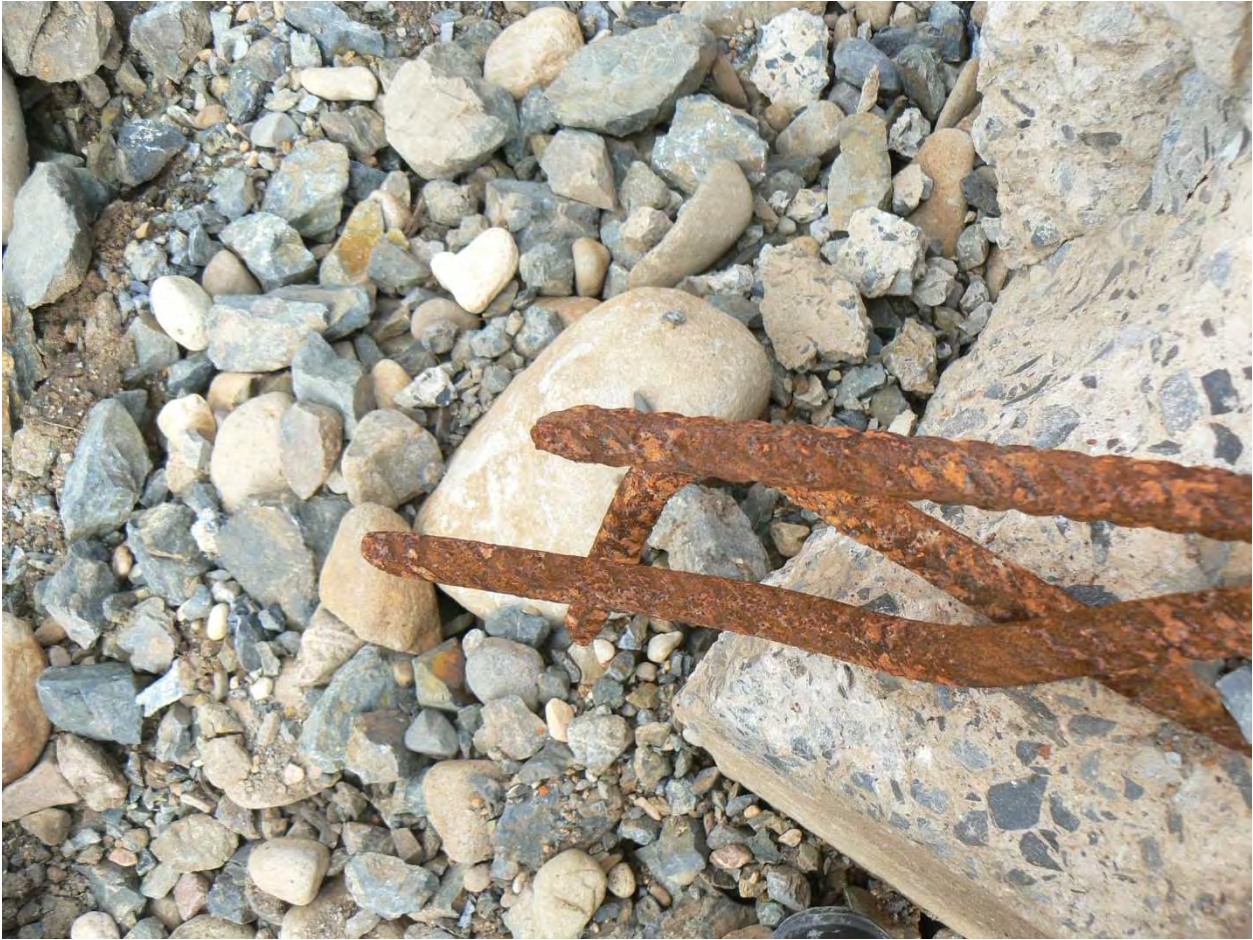
Photo 8 – Necking of Reinforcement Bars Indicating Tensile Overload

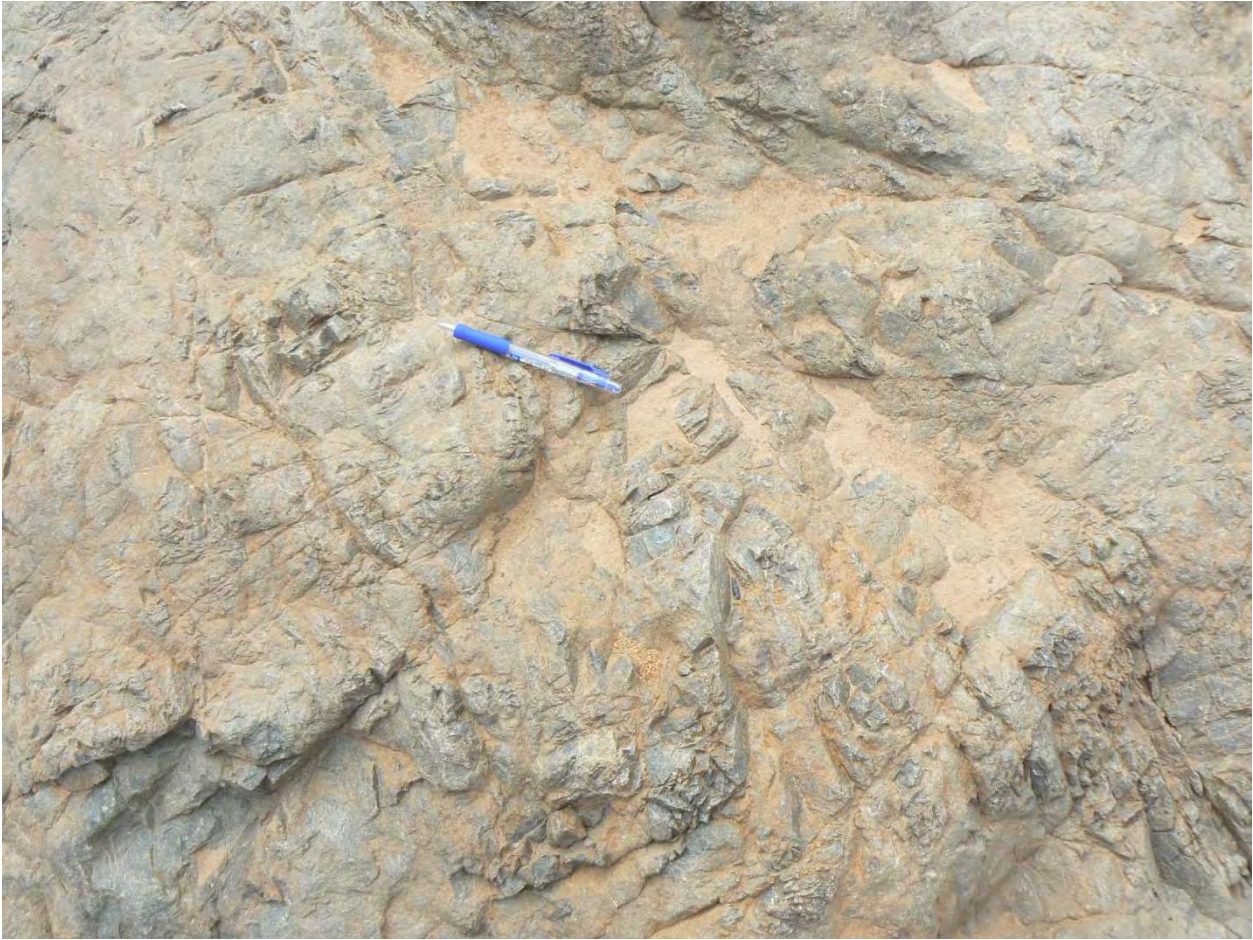
In this same vicinity a sample area of the exposed rock was examined. This inspection revealed a considerable variability in the rock conditions. In some places, as in **Photo 9**, the rock jointing was tight and the rock would be more resistant to scour. In other places the rock was very closely fractured with loose joints as can be seen in **Photo 10** and it would be less resistant to scour.

Photo 9 – Rock More Resistant to Scour

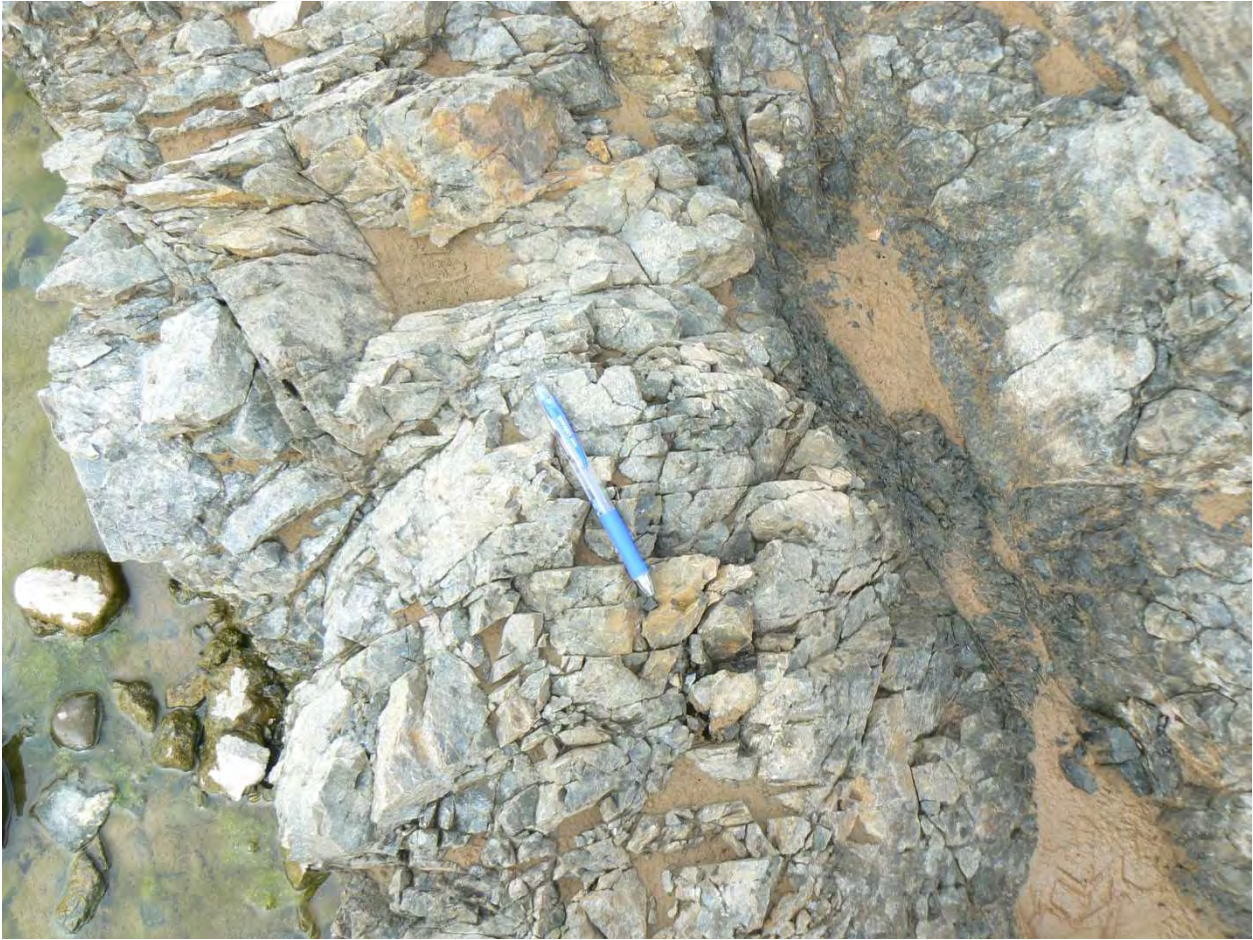
Photo 10 – Closely Fractured Rock Less Resistant to Scour

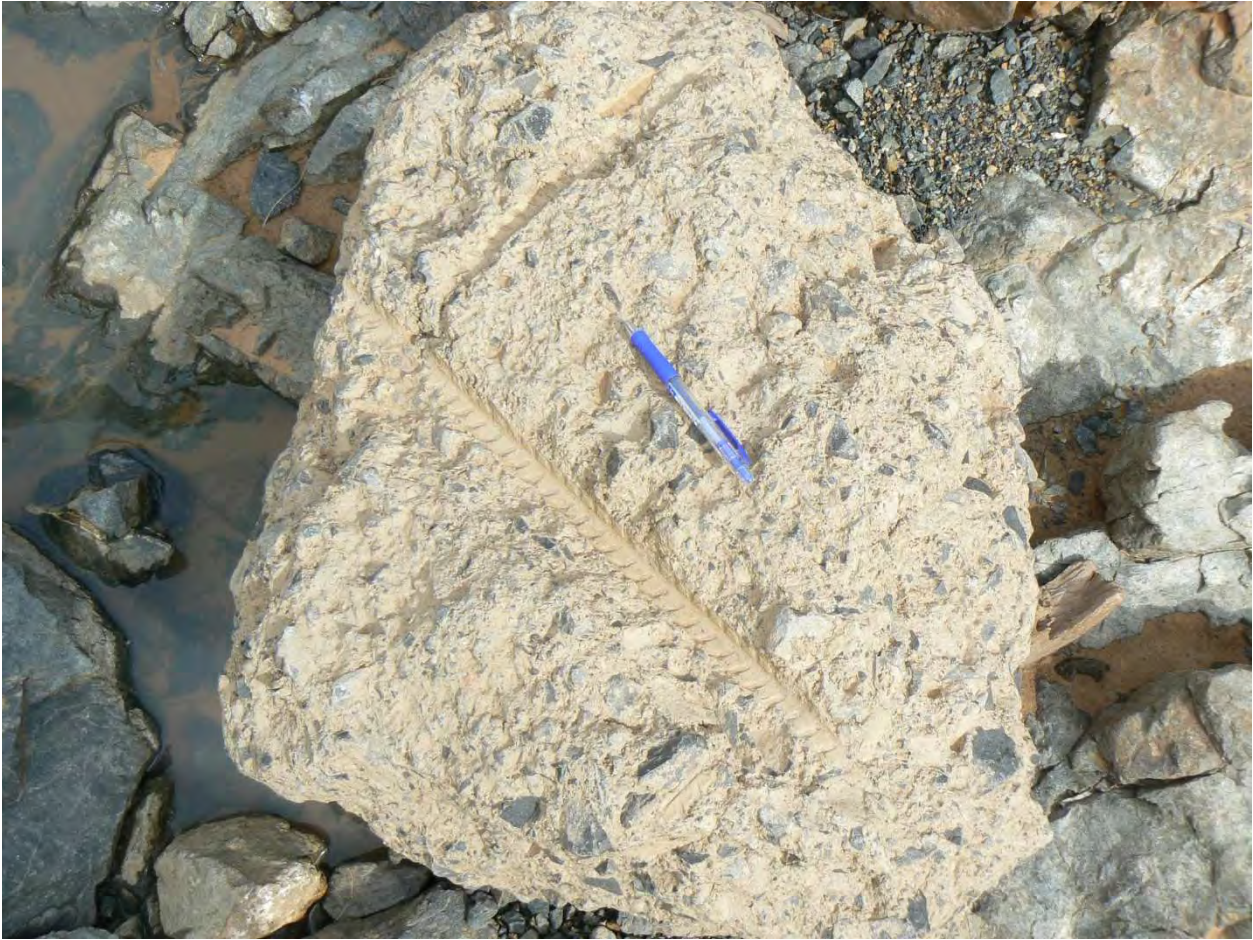
Nearby there was a slab of RCC from the dissipator apron. This slab had been rounded by abrasion in the turbulent flow of the flood. Significantly the impression of the reinforcing steel was visible, as seen in **Photo 11**. This is evidence of separation of the RCC along the plane of the steel under pounding of the overflow jet rather than failure by abrasion.

Photo 11 – Apron RCC Showing Separation at the Steel Level
