PARADISE DAM

FLOOD EVENT OF JANUARY TO MARCH 2013

REVIEW OF DAM SAFETY MANAGEMENT ACTIONS

REPORT NO. DC 13127

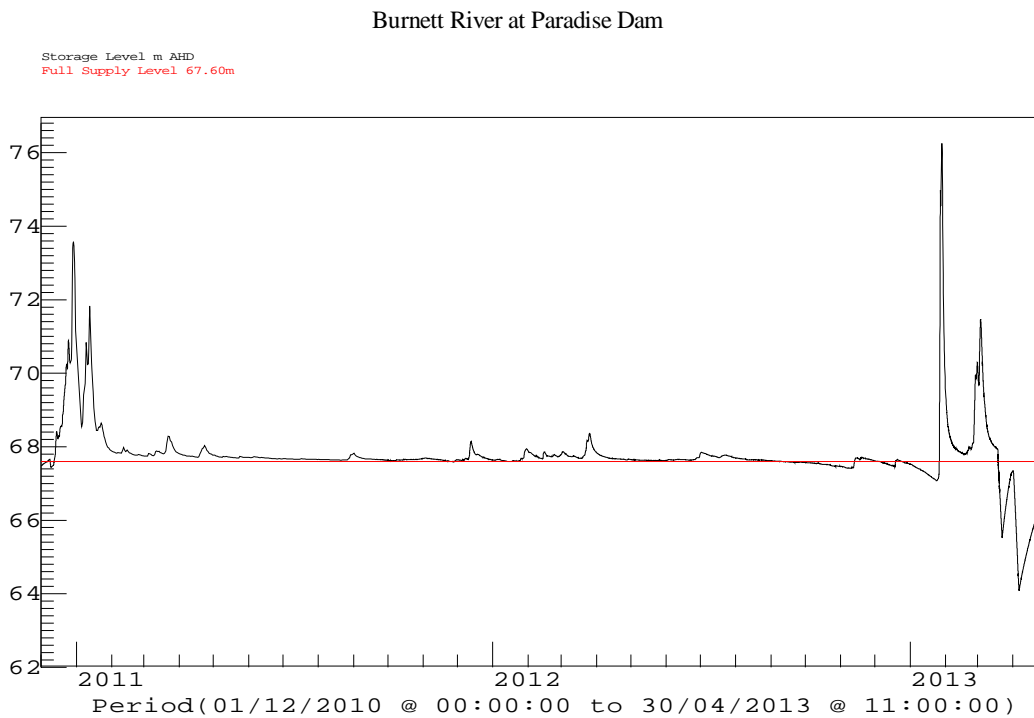
Figure 1 – Hydrograph of Paradise Dam Headwater Level

It will be seen from **Figure 1** that the difference between headwater level and crest level reached about 6.0m on 29 December 2010 at 0400h. The actual peak was recorded as 5.96m. There was a later peak of around 4.2m on 12 January 2011 at 2000h.

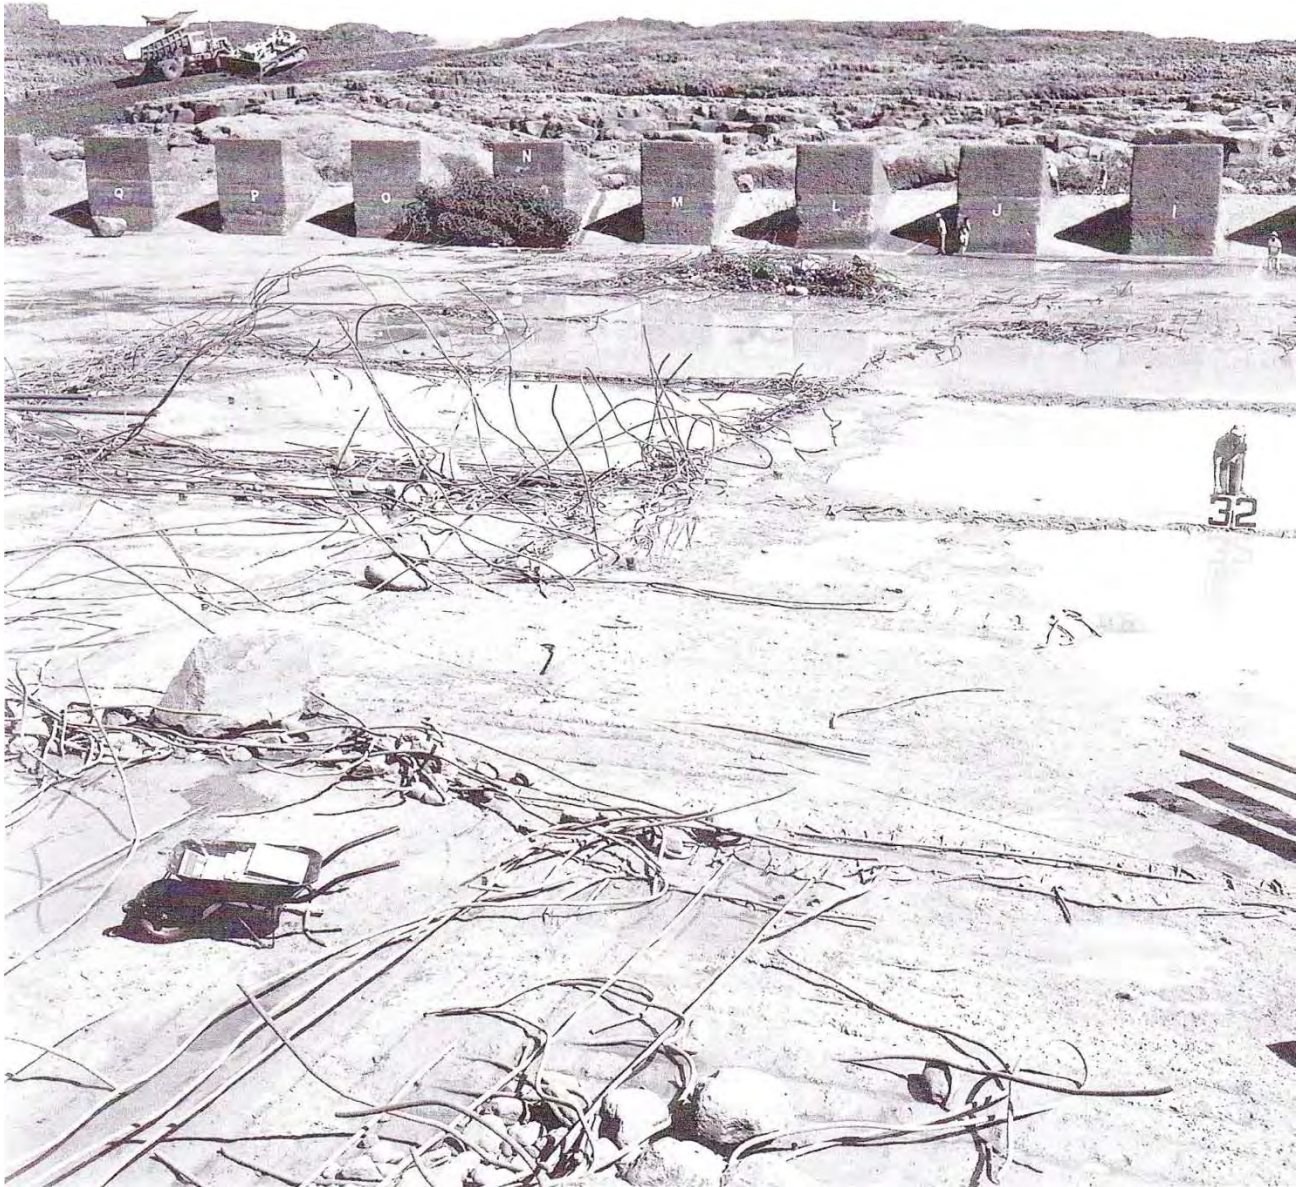
Figure 4 – Abrasion Damage to Marimbondo Dam Dissipator

Abrasion by rock and gravel has the potential to destroy a dissipator slab. CBDB (2002) describes the case of Marimbondo Dam in Brazil. In that case release of up to 6,356m³/s through the left hand spillway gates caused a recirculation flow which drew rock and gravel into the hydraulic jump dissipator. The dissipator apron was extensively abraded, in some places through to the foundation rock. Over significant areas up to 500mm of conventional concrete had been removed. **Figure 4** is an overview in which reinforcing steel can be seen rolled up by the flood in front of block N.

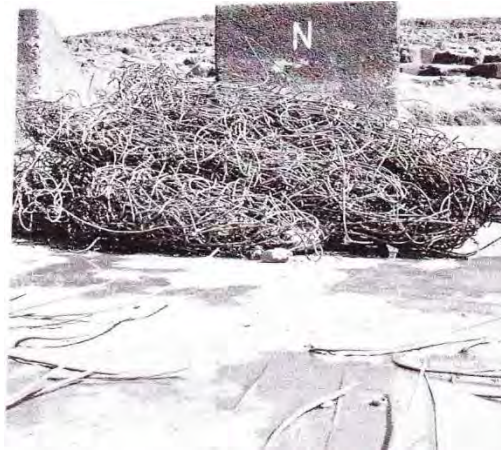
Figure 5 – Steel Torn out of the Dissipator Slab at Marimbondo Dam

Figure 5 below is a closer view of the steel rolled up by the flood.

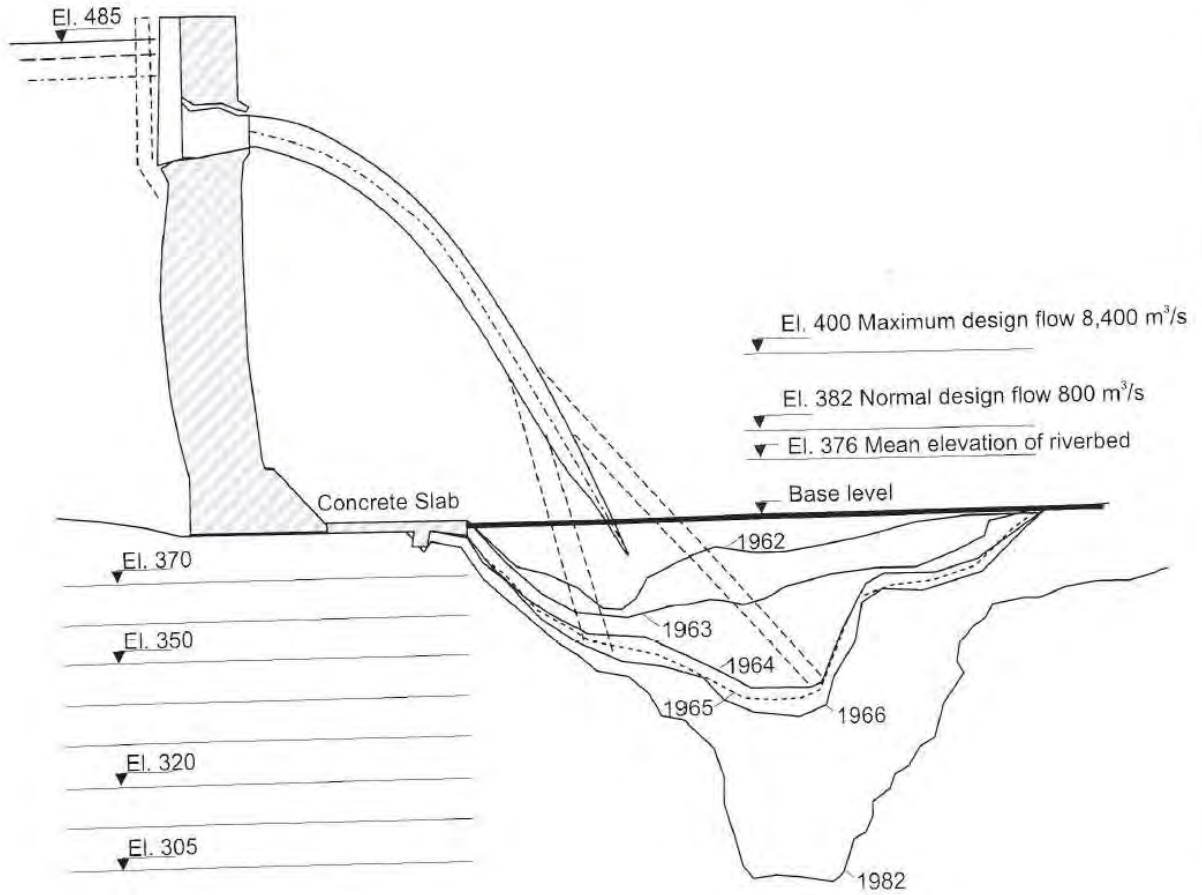
Figure 7 – Progression of Scour at Kariba Dam

2. The rock in the energy dissipation zone is susceptible to deep scour – inspection after the flood revealed major rock scour. There are some points to be made about rock scour in the energy dissipation zones of dams. Firstly, experience shows that major rock scour in a large flood is not necessarily the end of the scour process. The classic demonstration of this reality is the case of Kariba Dam on the Zimbabwe/Zambia border (Bollaert 2005). In that case scour continued from successive floods over decades, eventually leading to a scour hole over 80m deep. **Figure 7** from CBDB (2002) shows the progression. Conditions at Paradise Dam are quite different but the possibility of further scour cannot be ruled out on the evidence available at this stage. Secondly, experience of scour at large dams is highly variable for reasons which are not immediately obvious. Because of large flows in its rivers, Brazil offers instructive lessons on rock scour at dams (CBDB 2002). Foz do Areia and Salto Santiago dams on the Iguacu River and Machadinho and Ita Dams on the Uruguay River are all within the one geologic province of more or less horizontal basalt flows. All four dams have experienced large floods with comparable peak discharges in the order of 10,000m³/s to 19,000m³/s and comparable energy dissipation heads in the range of 90m to 130m. Yet Ita and Machadinho Dams experienced major rock scour with up to 200,000m³ of fresh rock being removed whilst the experience at Salto Santiago and Foz do Areia Dams was negligible rock scour. When these dams are examined in more detail it becomes clear that engineering judgment is a poor guide to the likelihood of rock scour and that account needs to be taken of detail metrics of unit power, stress relief factors, rock joint spacing, orientation and cementation among other factors. This reality points to the need to apply rock scour estimation methodologies such as those developed by Annandale and separately by Bollaert as an aid to judgment.

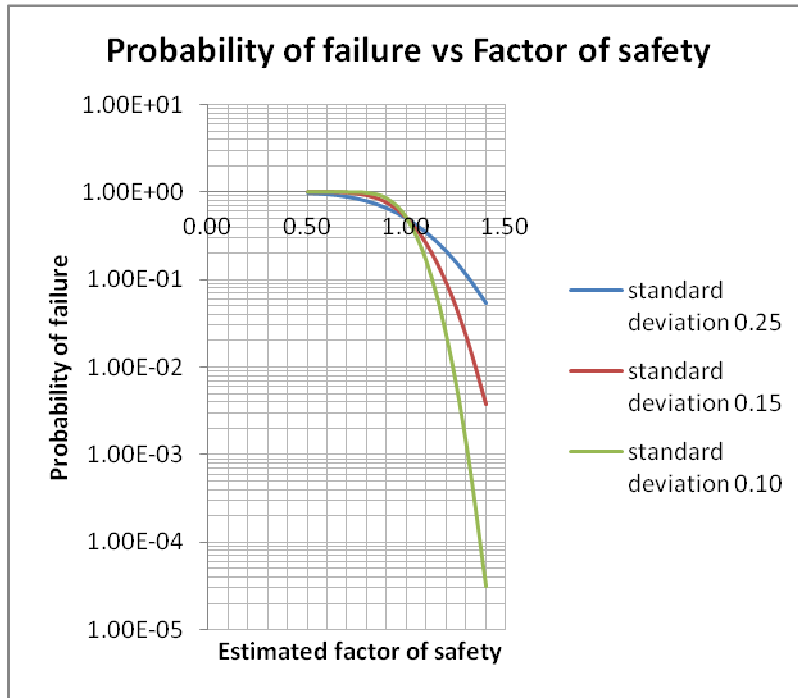
Figure 9 – Probability of Failure versus a Safety Factor

would be 1.0 (certain) for all load scenarios. Providing the estimates of demand (load) and capacity (resistance) are “best estimate” the probability of sliding can be informed by some equations from *reliability analysis*, especially for low values of the sliding stability factor. These equations estimate the probability that the real sliding stability factor is less than 1.0 (the definition of failure), given the estimated value of the sliding stability factor. If the uncertainty in the sliding stability factor is Normally distributed, an estimated sliding stability factor of 1.0 equates to a probability of failure of 0.5 neglecting model error, which is generally unknown. It is usually accepted that a Normal distribution is a reasonably good assumption. The uncertainty of the sliding stability factor has little influence at values of the factor close to 1.0 but has a large influence for large values of the factor. **Figure 9** is based on two formulae from *reliability analysis*.

Analysts should not rely on **Figure 9** but should consult authoritative texts on *reliability analysis* and make their own assessments. A brief treatment of the concept can be found at pages 339 to 342 of Hartford and Baecher (2004).

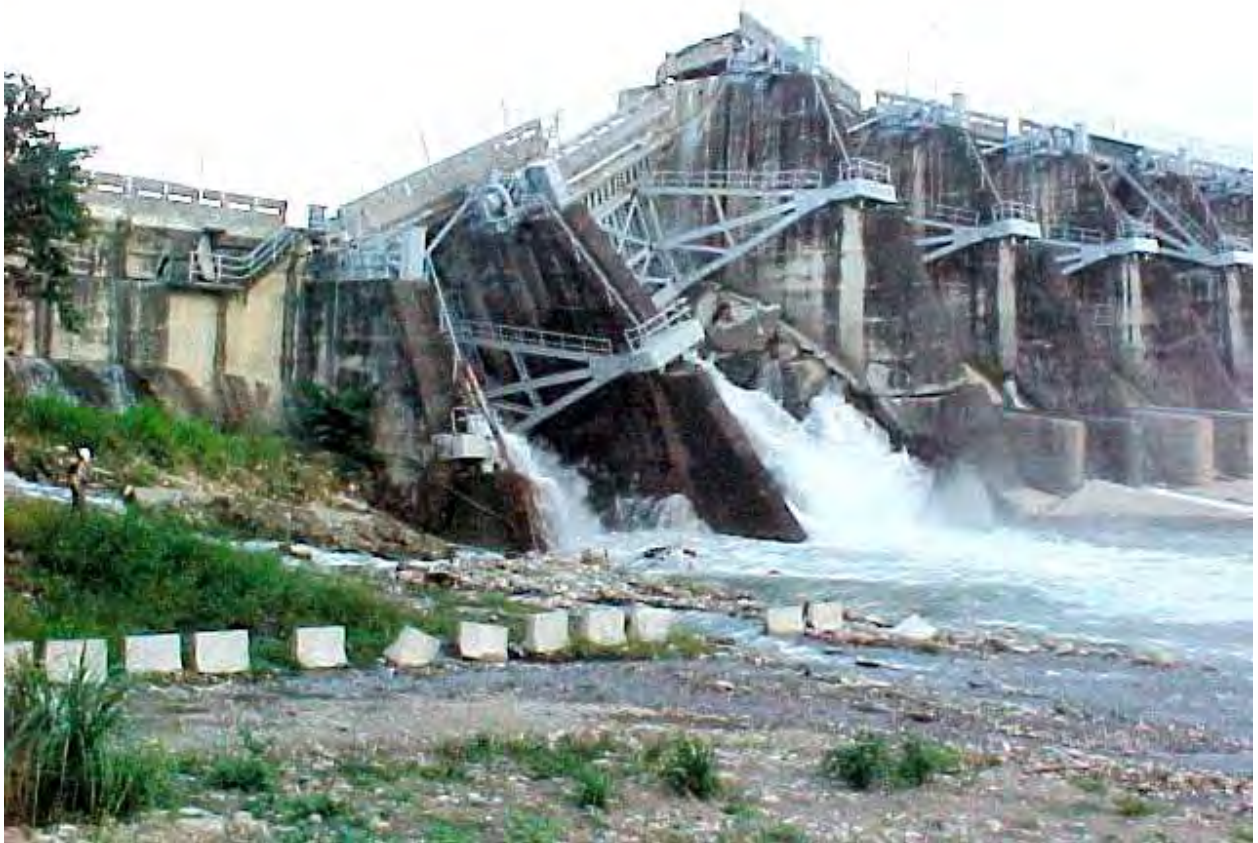
Figure 11 – Earthquake Damage to Shih-Kung Dam Taiwan

Activation of the EAP was a precautionary approach because it is highly unlikely that a gravity dam with the reservoir at or below FSL would fail after it has just survived the loading of a major flood. However, the time required for remedial works is such that the probability of strong earthquake shaking cannot be ruled out. No gravity dam has ever yet failed from earthquake shaking. An instructive case is that of Shih-Kung Dam in Taiwan, shown at **Figure 11**.

In the Shih-Kung Dam case a fault displacement of some 8m or more in the foundation of the dam destroyed two gravity blocks. But the significant point is that the adjacent blocks, though subjected to very strong shaking, did not fail and suffered little damage.
